Site Visit Observations & Recommendations

Part 2

4 Liermåsan & Blikrudmåsan

Client	County Governors of Oslo & Akershus	
Author	Deborah Land	
Contact	Sundew Ecology 10 Glebe Close Keswick Cumbria CA125QQ	sundewecology@gmail.com +44 7961 768101
Date	November 2018

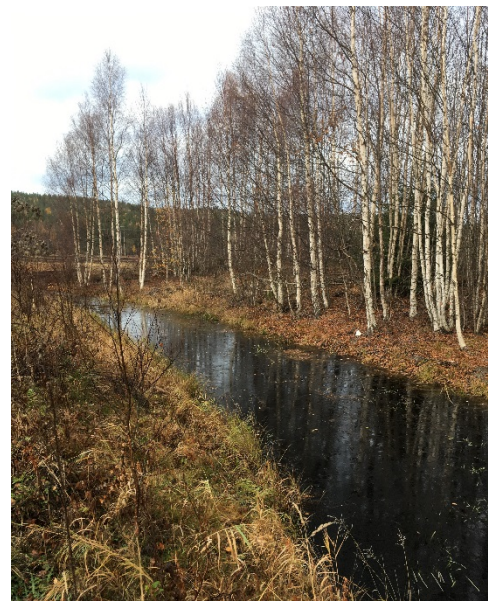
PHOTO 1 LARGE EXIT DRAIN TO LIERELVA

In addition to the regular in-field drains, there is also a large central drain taking water southwards and perimeter drains on either side also draining southwards. These have been dug into the peat body separating lobes of peat from the main body. The eastern drain issues via a very large drain into the Lierelva (Photo 1).

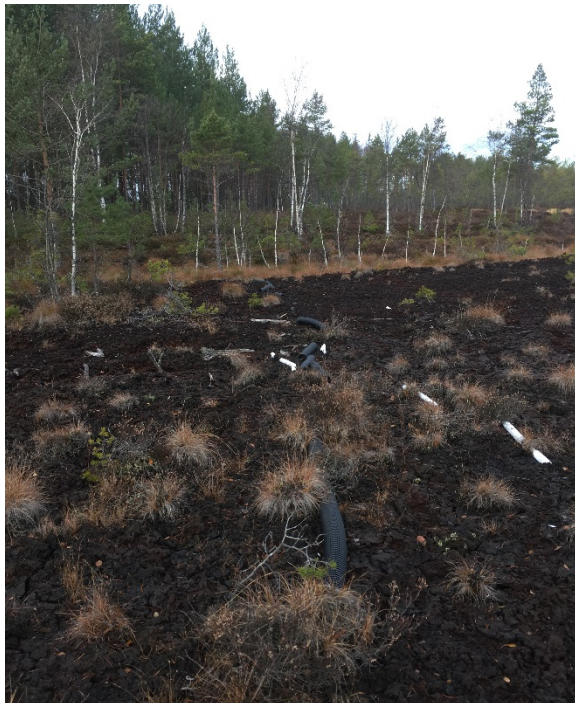
PHOTO 2 NORTHERN EXTENT OF LIERMÅSAN

Very little vegetation exists on Liermåsan, confined to small dry remnants of bog vegetation on the old block cut areas and some modified vegetation at the northern extent of the site. This area also revealed signs of previous agricultural improvement through the installation of perforated pipe drainage (Photo 2).

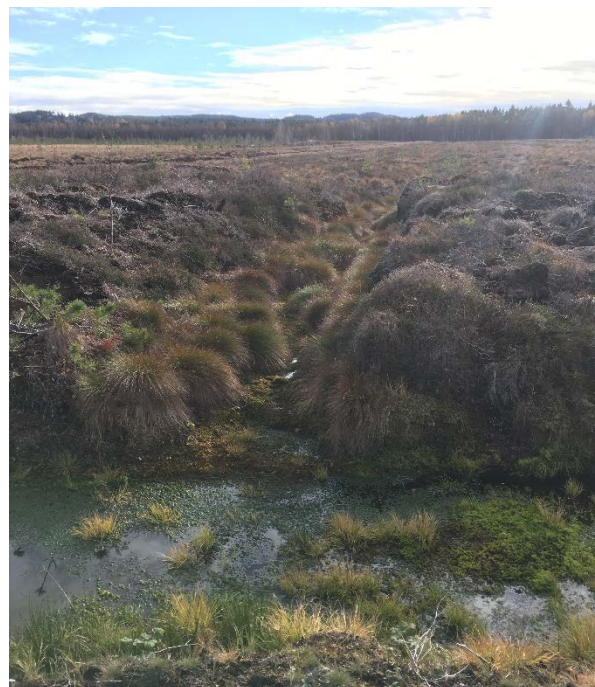
PHOTO 3 NATURAL RE-VEGETATION ON BLIKSRUDMÅSAN

Blikrudmåsan has better coverage of vegetation dominated by Hare's-tail cotton grass *Eriophorum vaginatum* with frequent hummocks of sphagnum. The site however is still drained by a network of active ditches (Photo 3)

The restoration of Blikrudmåsan is far more straightforward since much of the site supports some pioneering bog vegetation. The methodology here would be simply to block the network of drains to maintain a stable water table within the peatland.

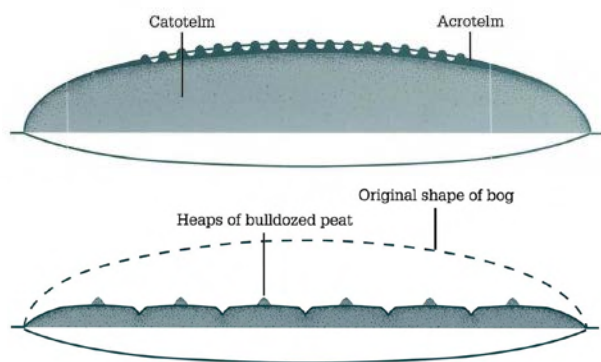
FIGURE 1 INTACT VS MILLED BOG (LINDSAY, 1995)

A functioning lowland raised bog is an ombrotrophic system and is therefore entirely rain fed and nutrient poor. It will comprise a domed landform sloping into the rand and lagg zone with the mineral interface. Milled peatland lack this landform and the active acrotelm along with some of the catotelm has been removed (Figure 1). The hydrology of this site has been severely affected.

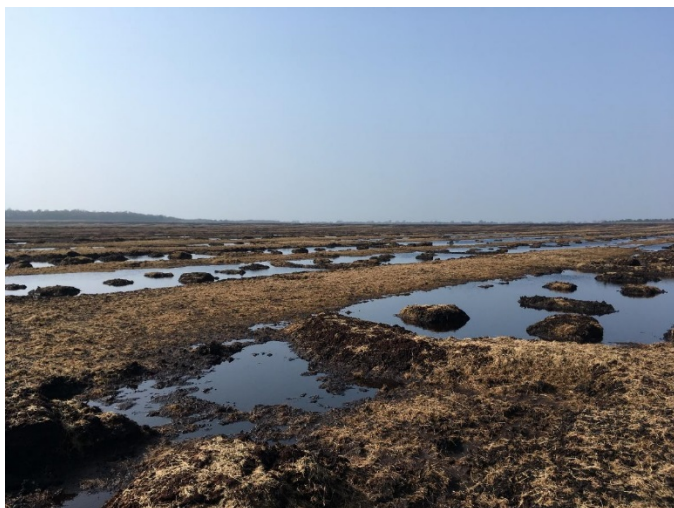
PHOTO 4 ONE OF THE MANY DESIGNS OF BUNDS AND DAMS

The creation of low bunds can also prevent water movement and help create a microclimate favourable for bog vegetation. They are particularly useful to retain water over a gradient. There have been many different designs used but the shape is secondary to the size and height (Photo 4). Too tall and too greater area and too much water will be held preventing colonisation. Small subtle bunds are more effective, maintaining a shallow film of water just above or at the surface.

The restoration of the hydrology favourable for bog vegetation will rely upon carefully designed dams and bunds. While the drains should be blocked with peat dams at regularly intervals, retention of open water between the dams provides a valuable potential habitat.

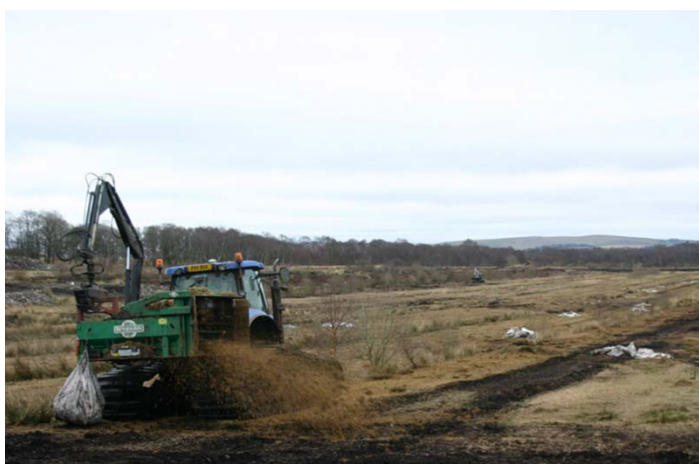
PHOTO 5 APPLICATION OF DONOR MATERIAL WITH GRASS MULCH

The Canadian approach applies the donor material with a mulch of straw for protection. A recent development in the UK uses a mulch of cut grasses and mosses from a peaty acid grassland site and mixes this with the donor material prior to application to the surface (Photo 5). The matrix of cut grasses adhere to the peat surface and provide a nutrient source for the pleurocarpus mosses to establish. The matrix maintains moisture and provides an ideal surface for the donor sphagnum to become established (Photo 6).

The donor material should be obtained from a nearby source. Vålermåsan would be an ideal donor site for Liermåsan. Harvesting should aim to cut the top 10cm of the Sphagnum in long narrow strips to minimise the impact to the donor site. Cutting must minimise damage to the donor material and is likely to necessitate specialist lightweight machinery. The ratio of donor to receptor site is between 1:15 and 1:10 (Quinty & Rochefort, 2003).

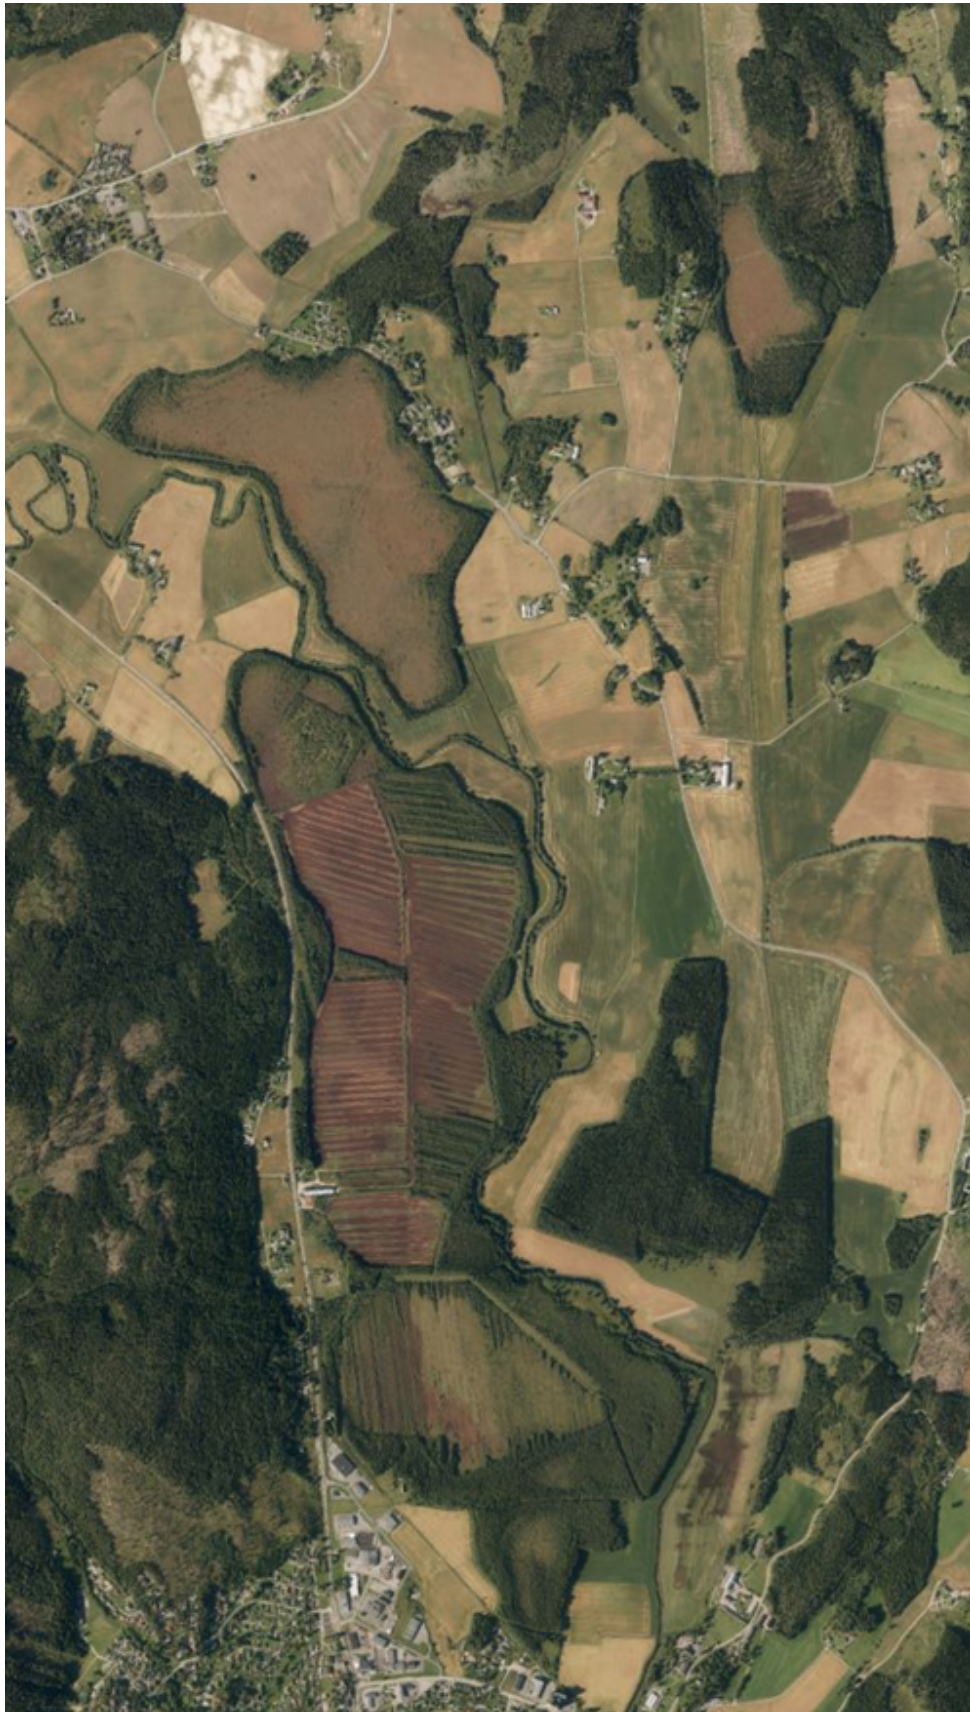
MAP 1 MIRE MACROTOPE (NORGEIBILDER.NO, 2016)

Liermåsan & Blikrudmåsan together with its intact neighbour Vålermåsan, are a macrotope of concentric mires located north of Bjørkelangen, within the municipality of Aurskog-Høland, in the County of Akershus. The mires have formed in a wide river valley, which also supports a number of smaller mires (Map 1 & 2).

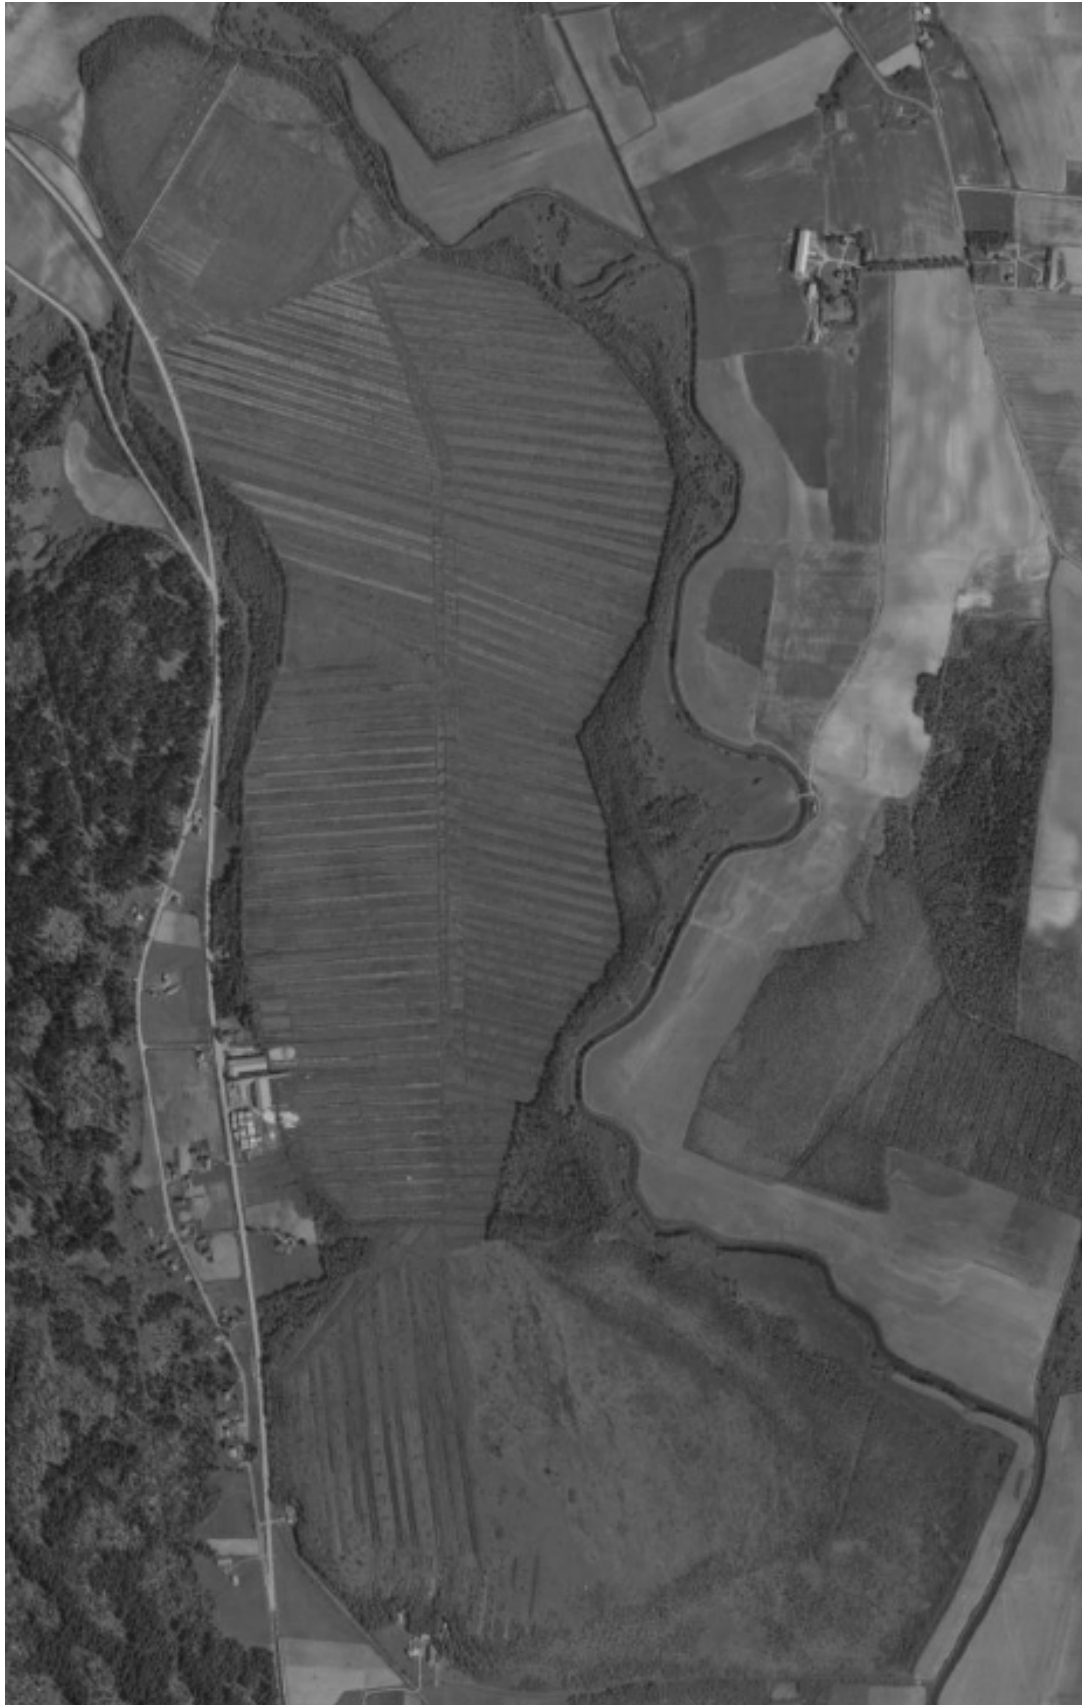
MAP 3 HISTORICAL AERIAL PHOTOGRAPH (NORGEIBILDER.NO, 1967)

The earliest available aerial photographs date from 1967 and clearly show extensive peat excavation across both Liermåsan & Blikrudmåsan (Map 3). The original method would have been hand cutting but this would have given way to the more efficient machine block cutting. This method cuts and stacks the peat leaving it to dry until light enough to transport. This method leads to leaving a pattern of hollow and raised areas referred to as “baulks” before abandoning the area (Manatoba Peatlands, 2018). Two areas of old block cutting are still evident.

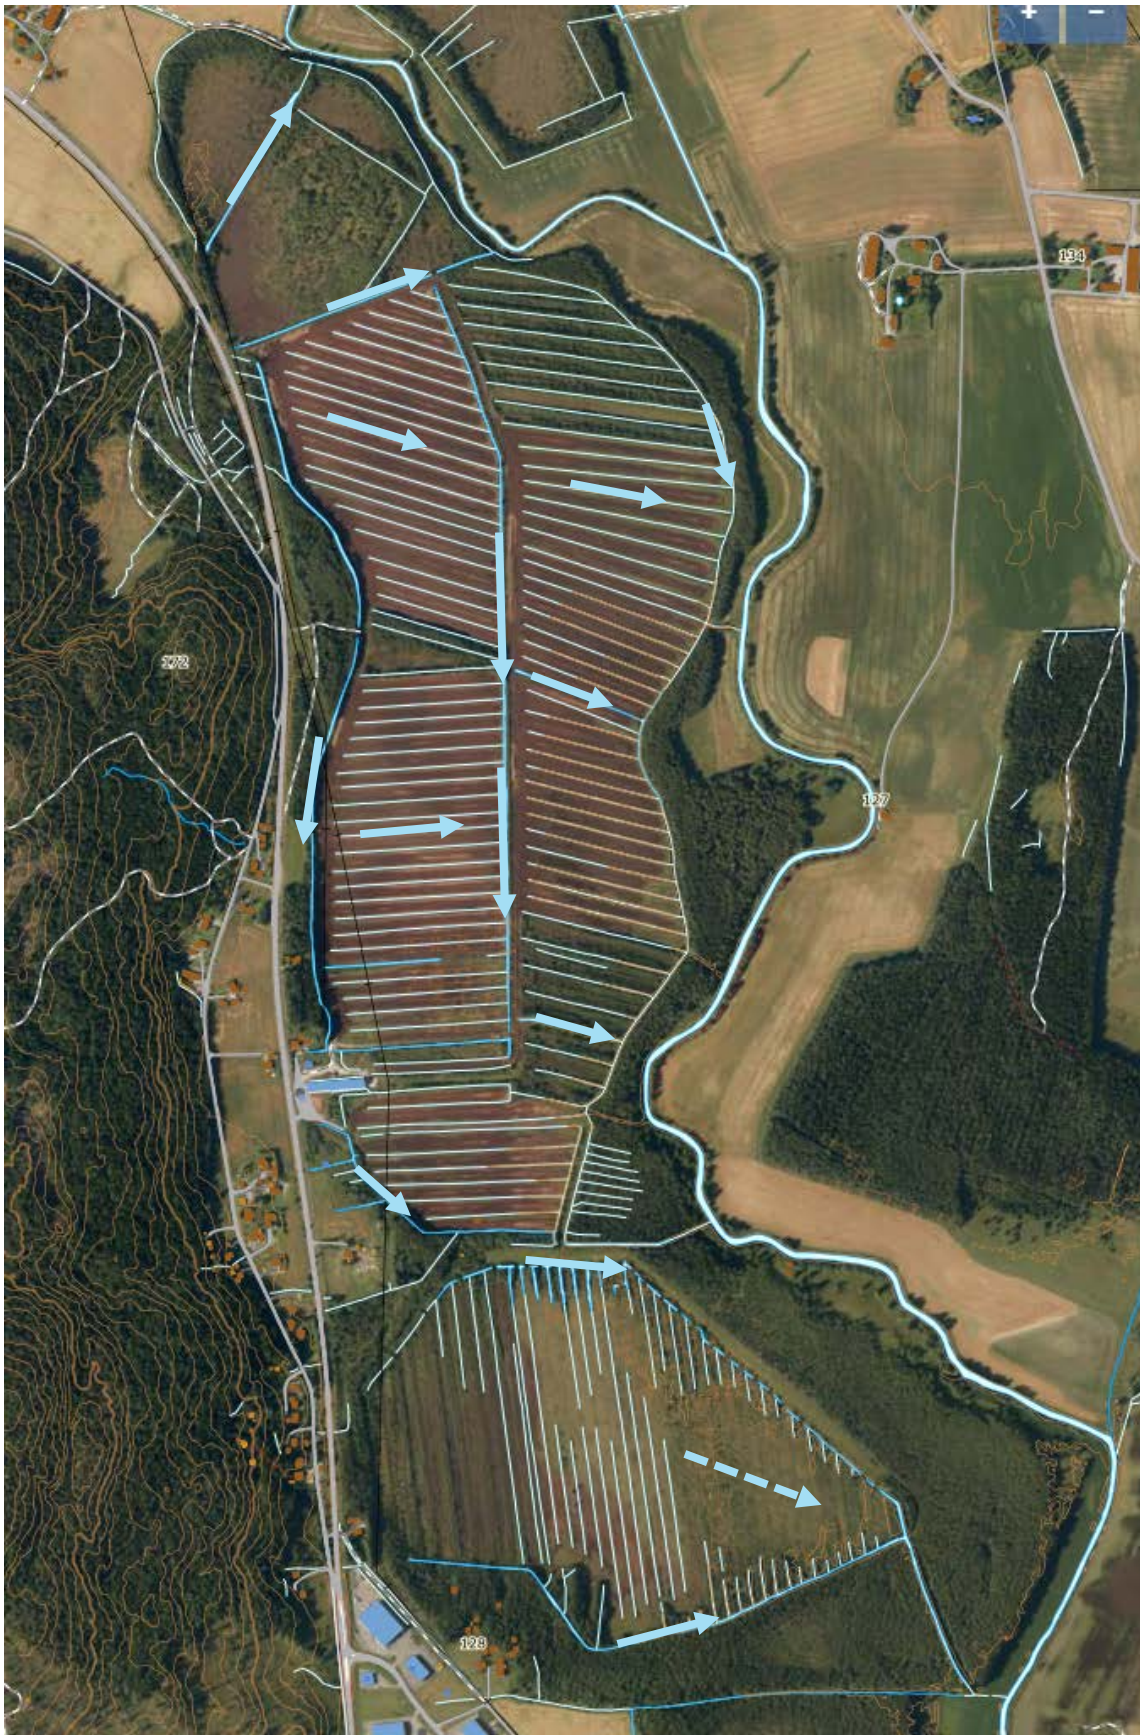
MAP 4 DRAINAGE NETWORK AND DIRECTION OF FLOW (GEO.NGU.NO, 2018)

Peat milling on the other hand relies heavily on the establishment of an efficient network of drainage (Map 4). The surface is levelled and drains placed approximately 15m apart creating large flat milling fields. These are often cambered to aid drainage. Once established, these milling fields can support the heavy extraction machines such as a vacuum harvester. As the peat depth decreases with every harvest, more and more drainage is needed, requiring drains to be dug deeper for the next harvest season (Manatoba peatlands, 2018).
